Facilitated Learning Analysis

March 6, 2014

Schnetzer Fire Injured Sawyer
Facilitated Learning Analysis
March 6, 2014

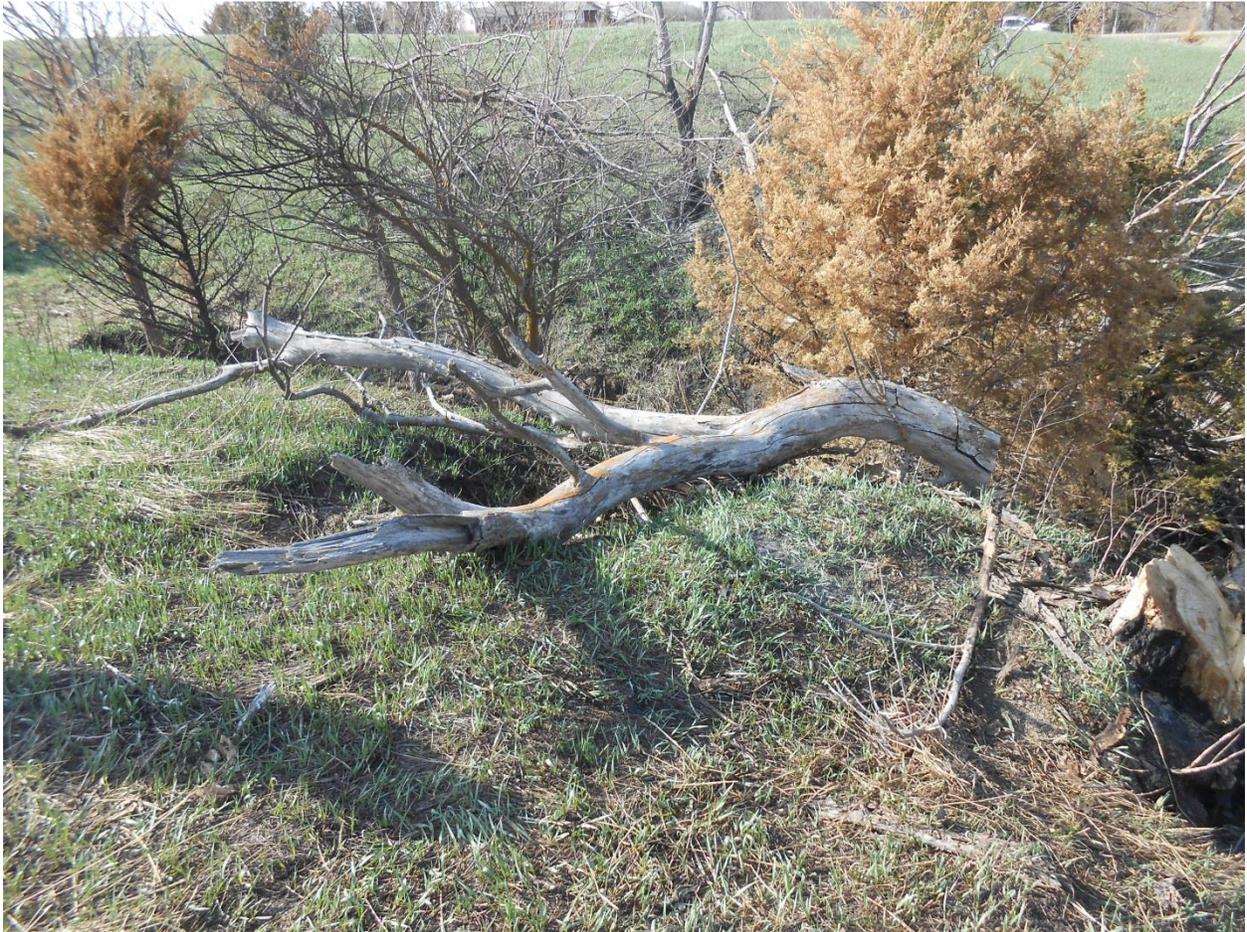
Accident site. Closest branch struck FF1.

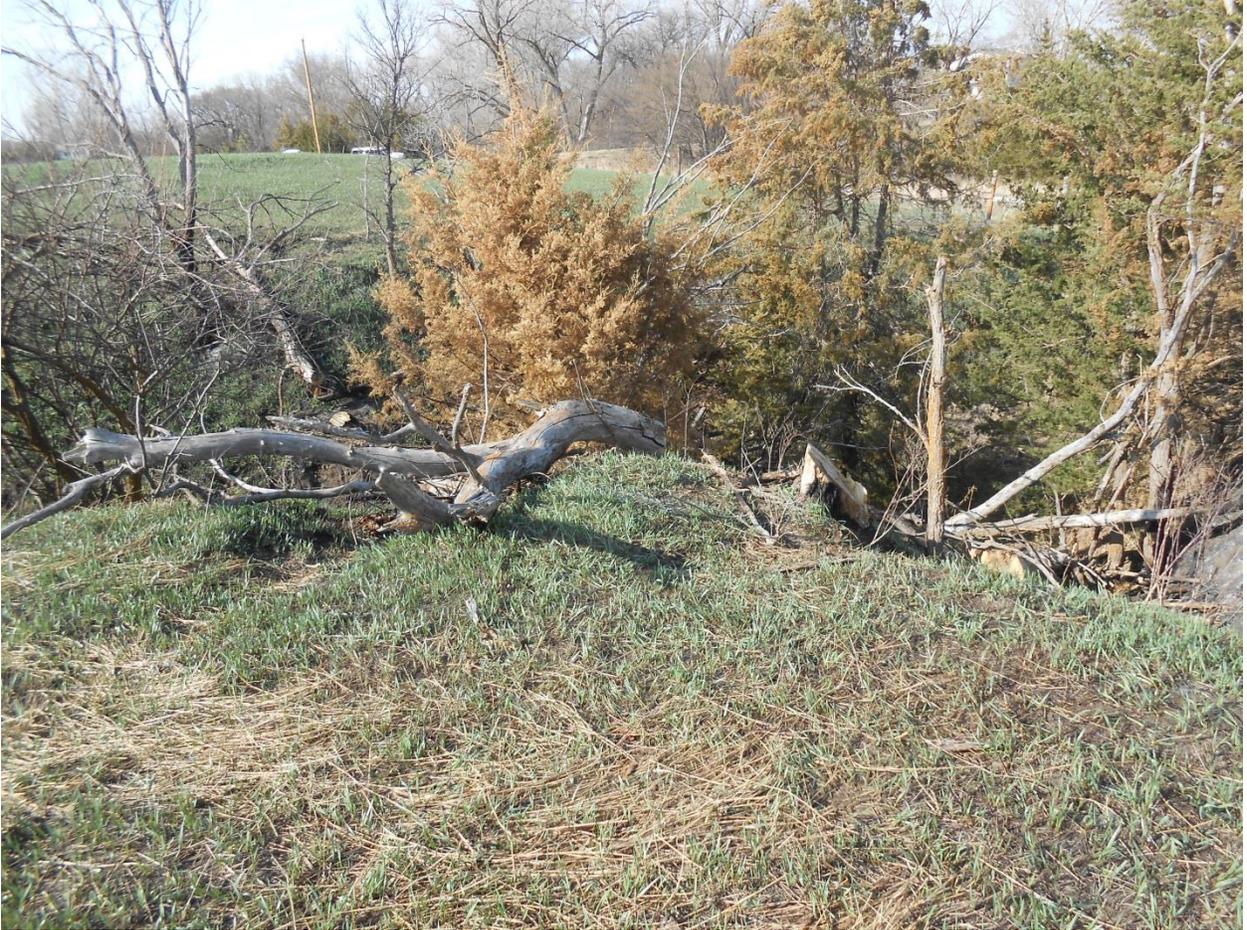
Accident site.

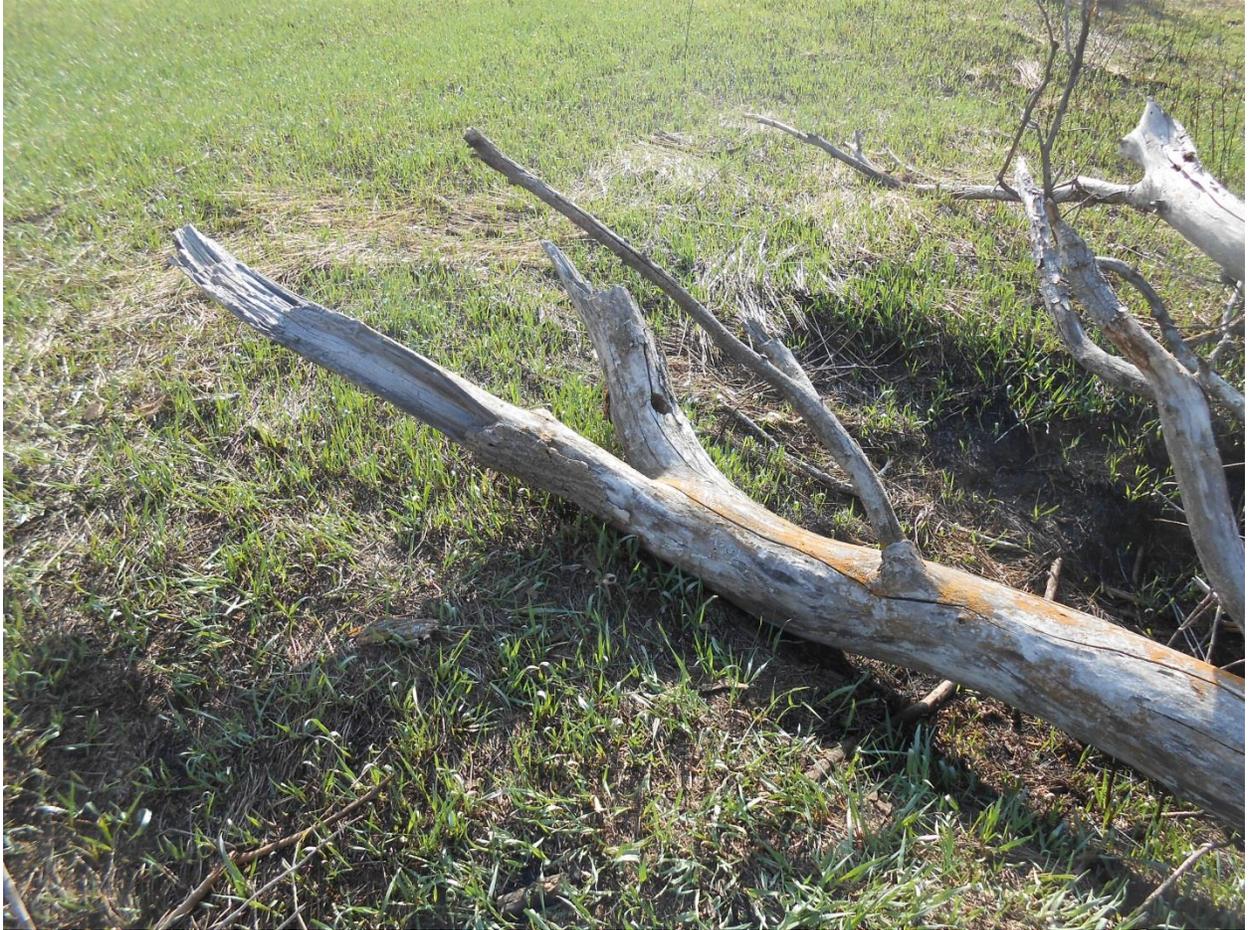
Top of cut section. Branch to the left struck FF1.

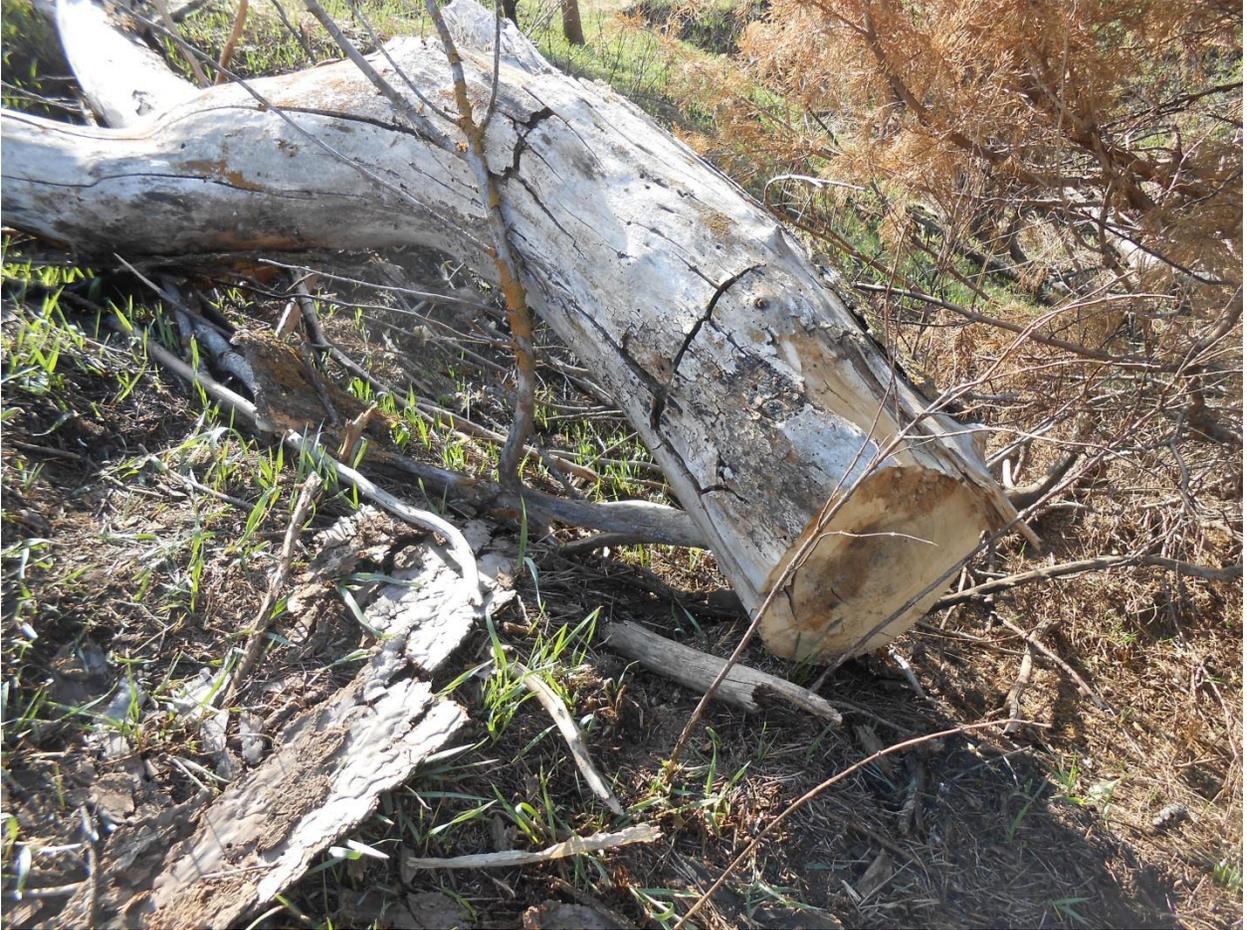
Cut end of section which struck FF1.

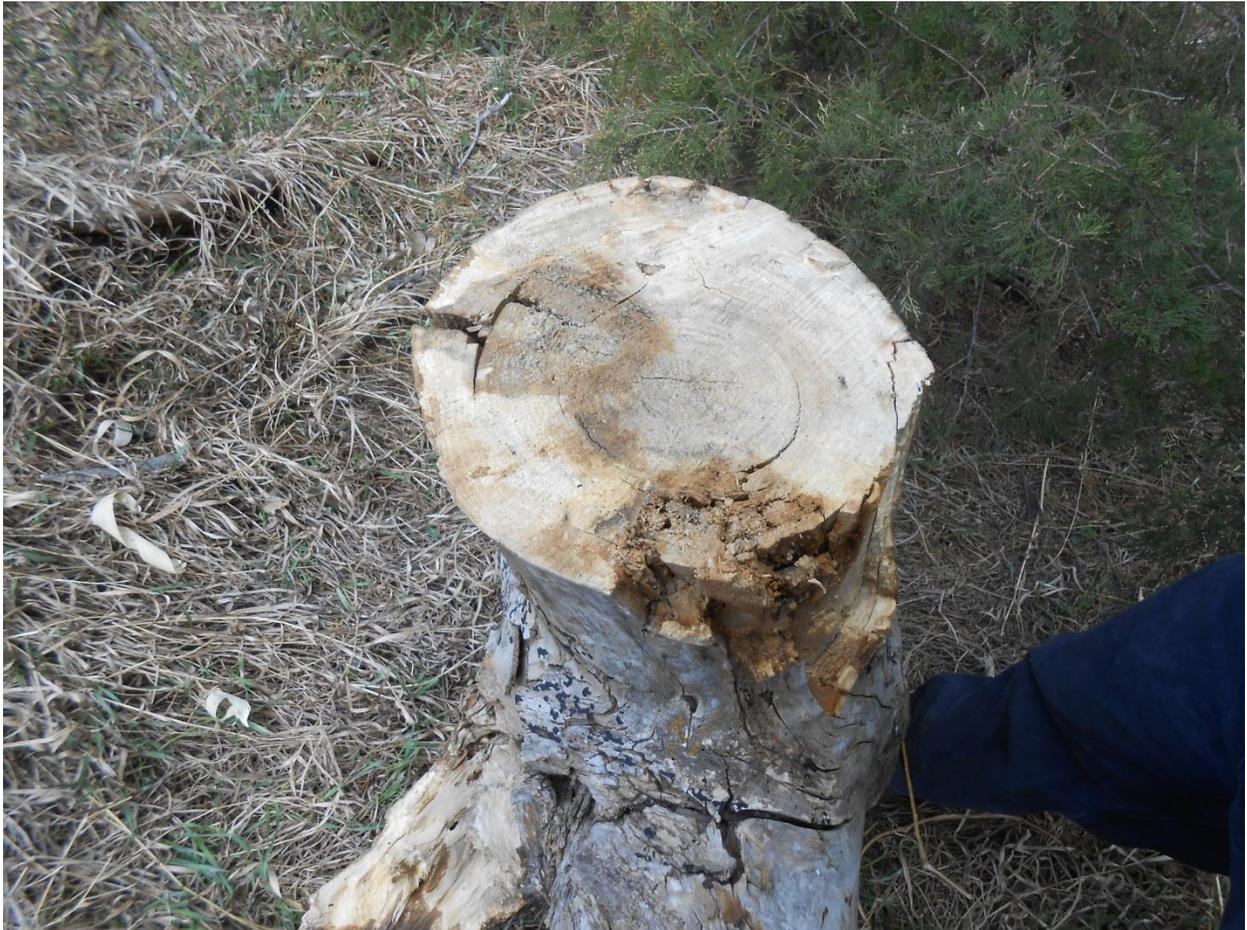
Rotted wood in cut made by FF1.

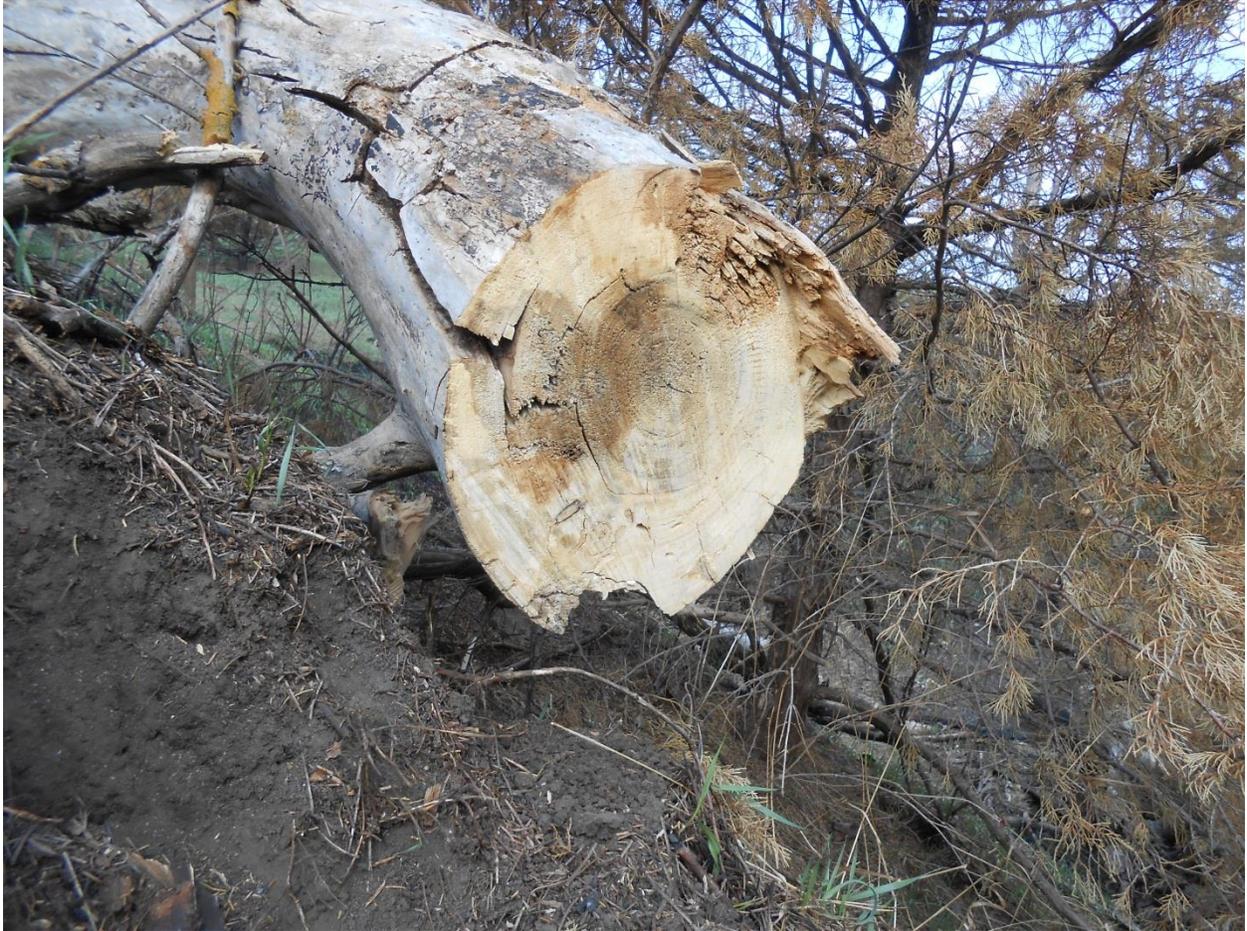
The cut was made too high on the bole/trunk.

No face cut and hinge was used to control the direction of fall of the tree.

Butt of section which struck FF1 showing the cut.

Use proper face cuts to control the direction of fall. There was no face cut made to supply a hinge to control the direction of fall. The firefighter was cutting straight through and relying on the other firefighter being able to push the tree in the desired direction.

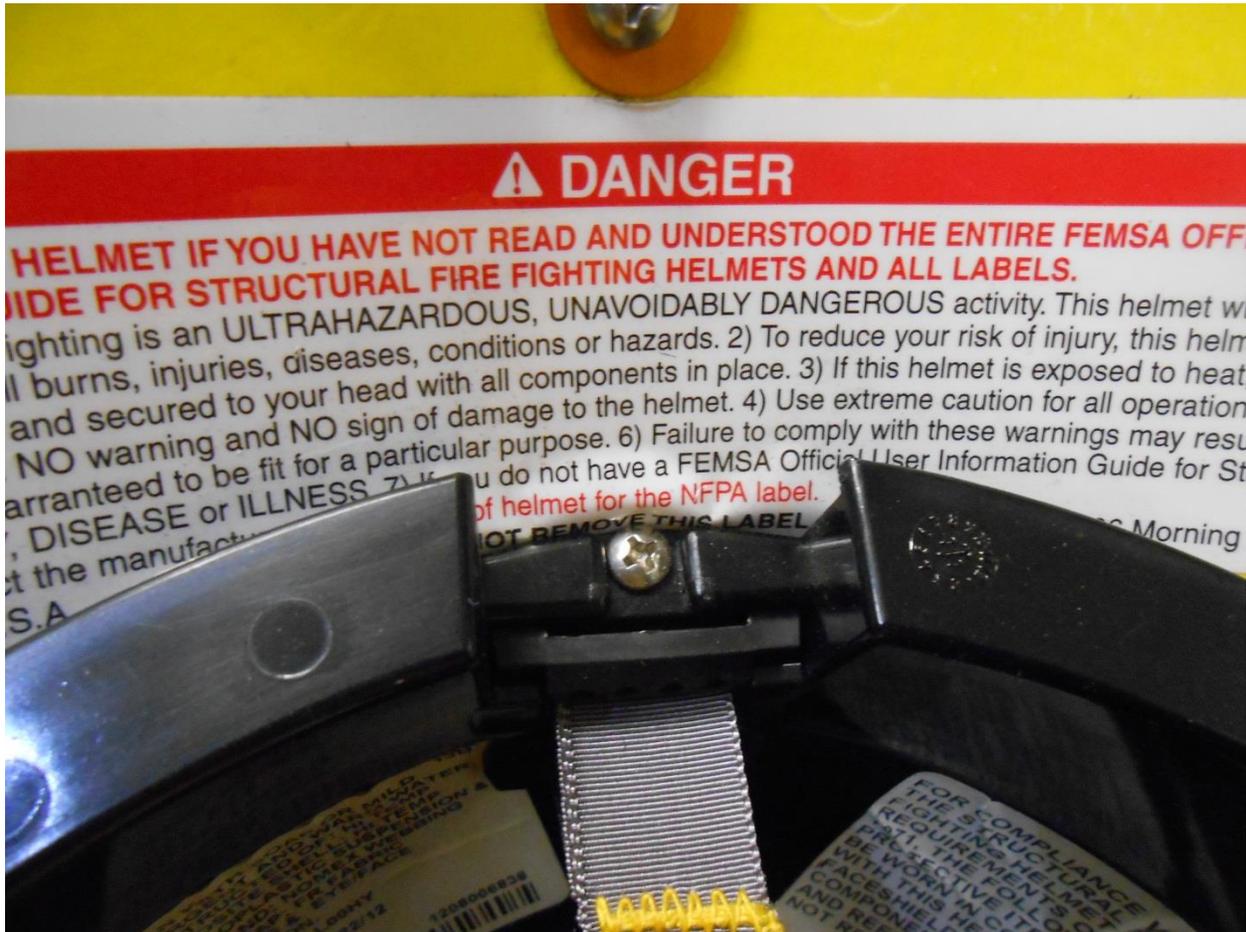
Wildland PPE is supplied to the members of the department but due to the cold temperature and winds, they opted to wear structural PPE. The structural helmet showed significant damage on the right side behind the mount for the face shield. There is a 6" crack starting at the edge brim and continuing upward towards the top of the helmet. The back piece of the headgear was driven into the rear brim of the helmet and slightly deformed the area where the brim meets the main helmet. The helmet was manufactured 8/12 to NFPA 1971 standards and was purchased last year.

Rear of headgear pushed into brim of helmet.

Always use personal protective equipment. The weight of the piece that fell was estimated at weighing around 250 lbs. Considering the amount of damage to the helmet, the use of structural PPE instead of wildland PPE contributed greatly to the survival of the firefighter.

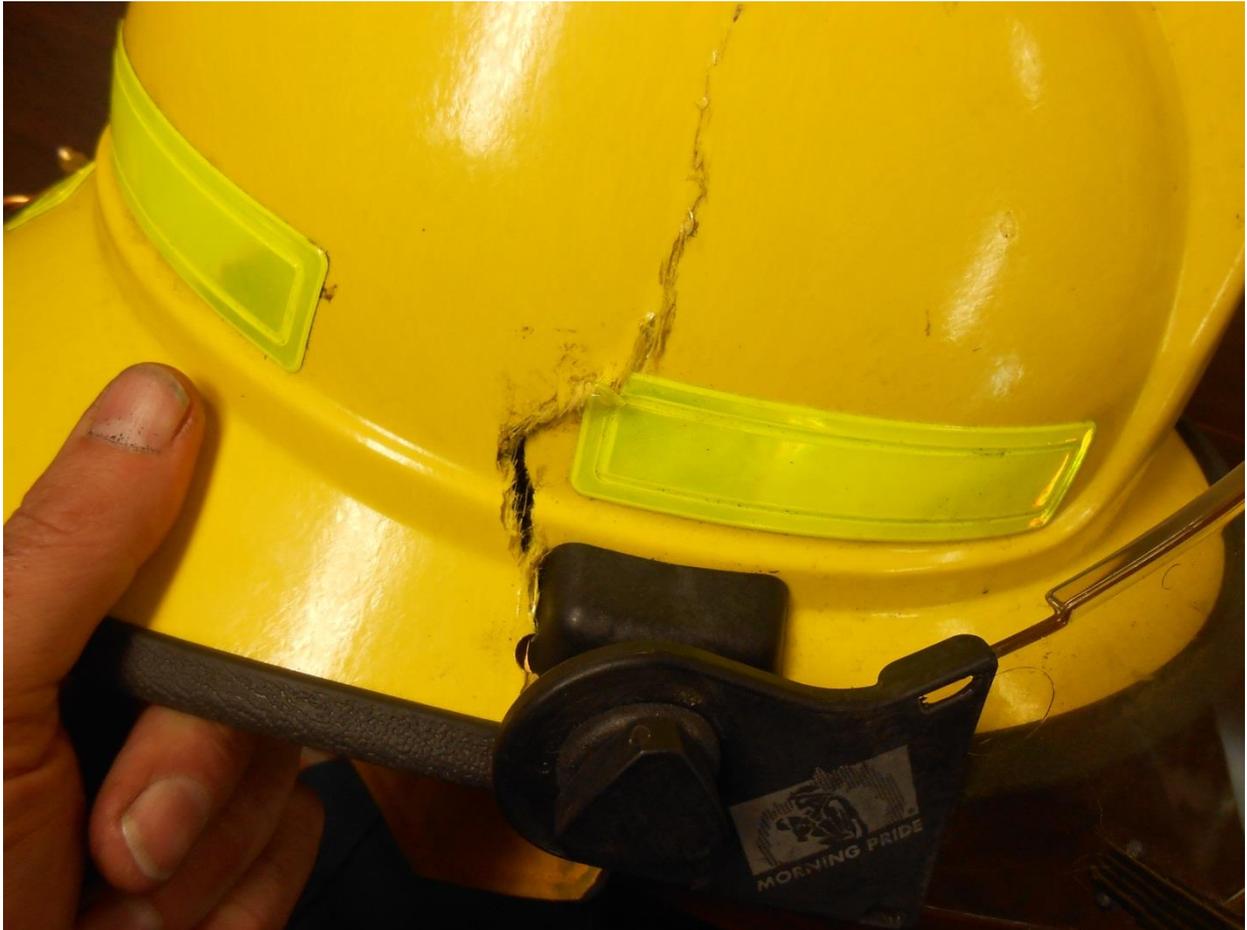
Damage to the right side of helmet.
