Tripp Lake Road Fire Entrapment

October 6, 2011

Tripp Lake Road Fire

Tripp Fire Department

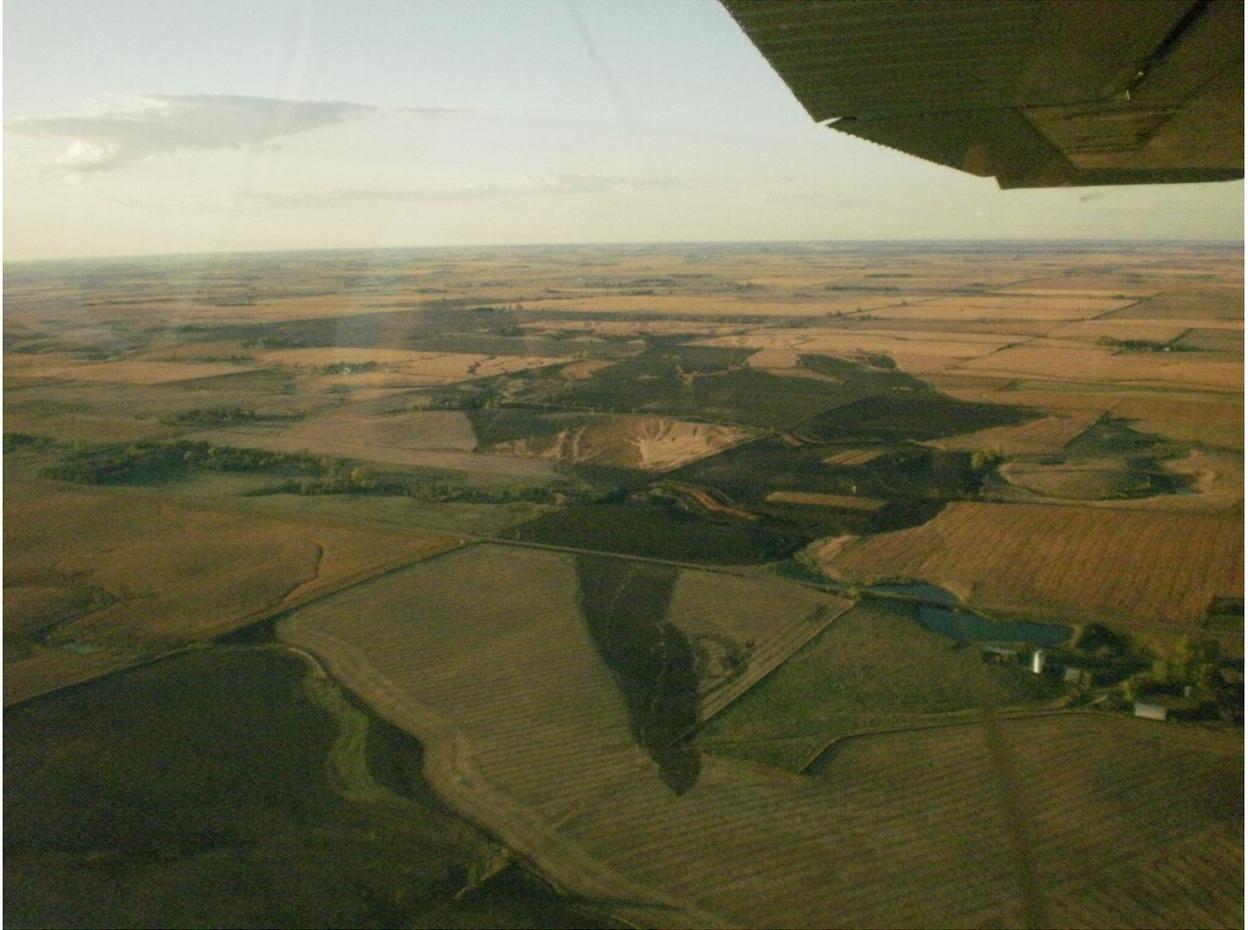
Looking Northeast from point of origin

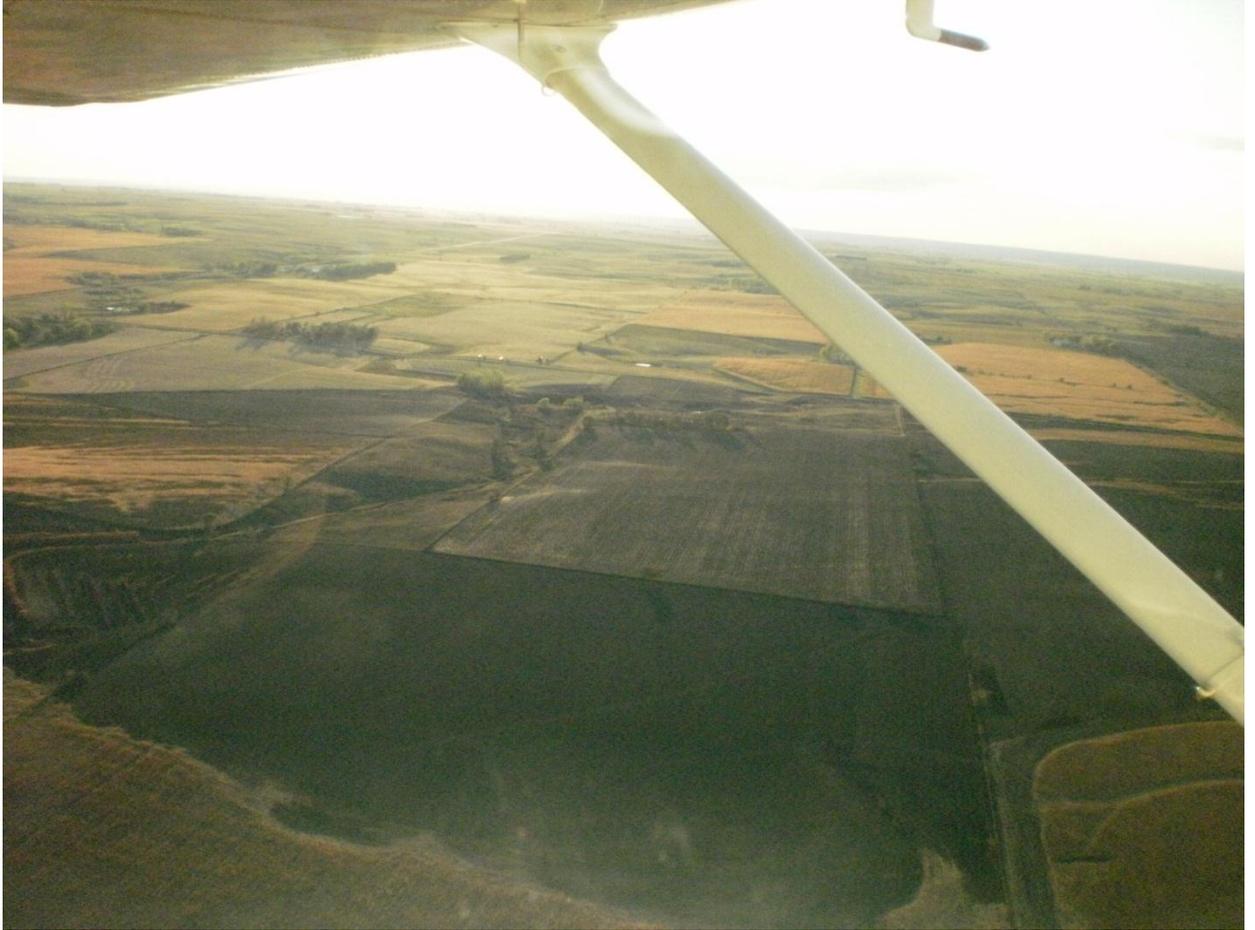
East flank of fire looking west

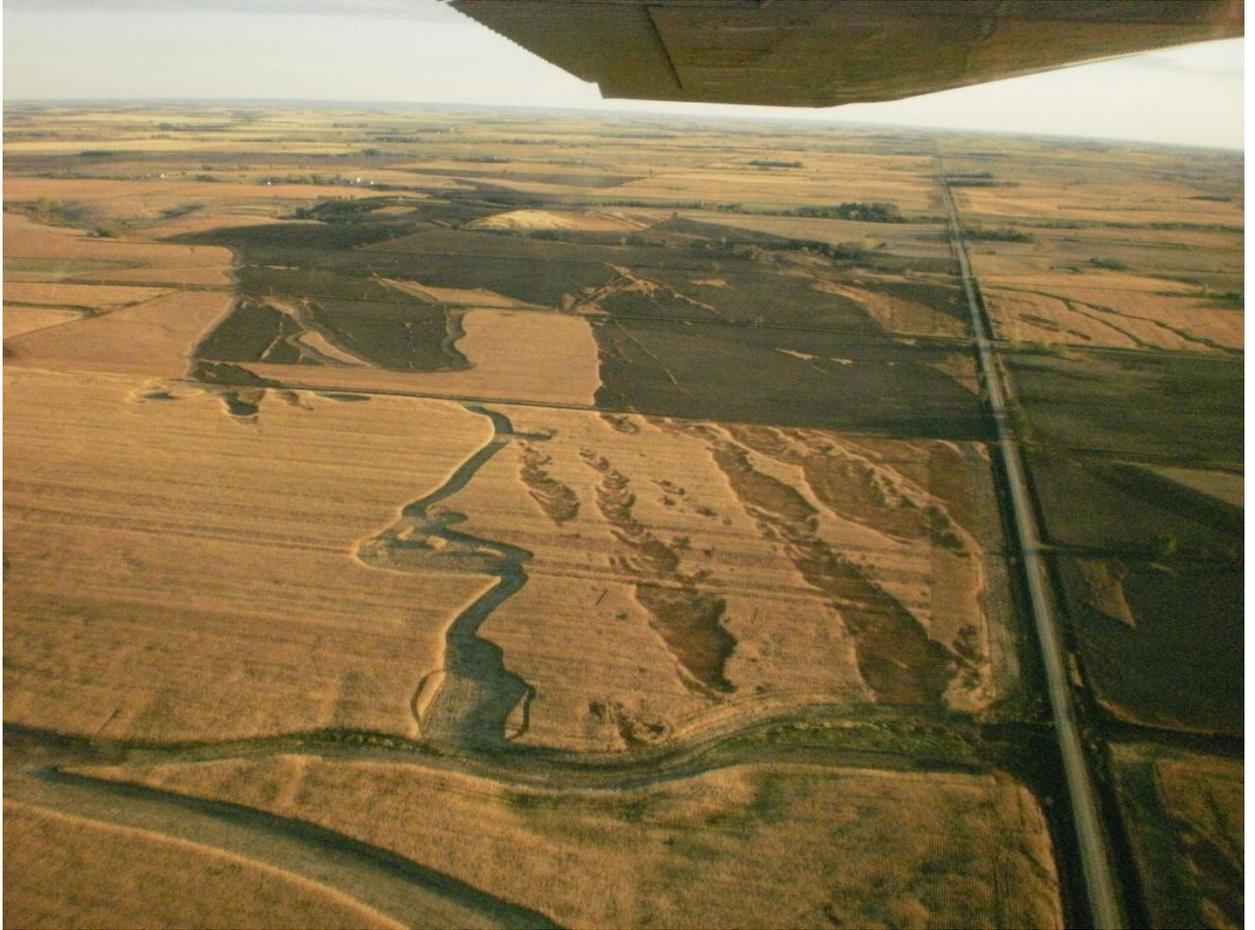
Northwest corner of fire looking south

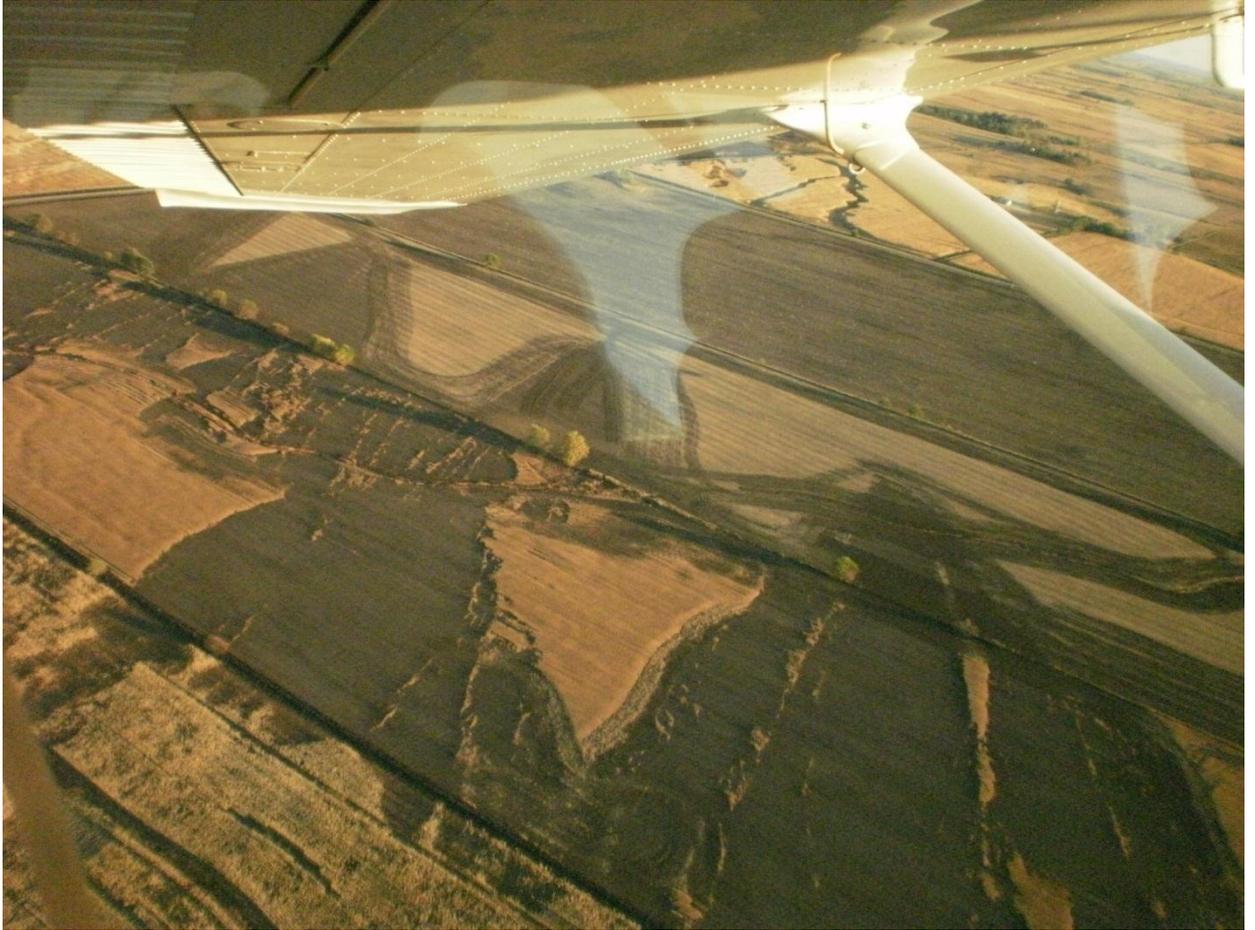
West side of fire. Notice new starts on north side of fallow field from spotting (1/4 mile)

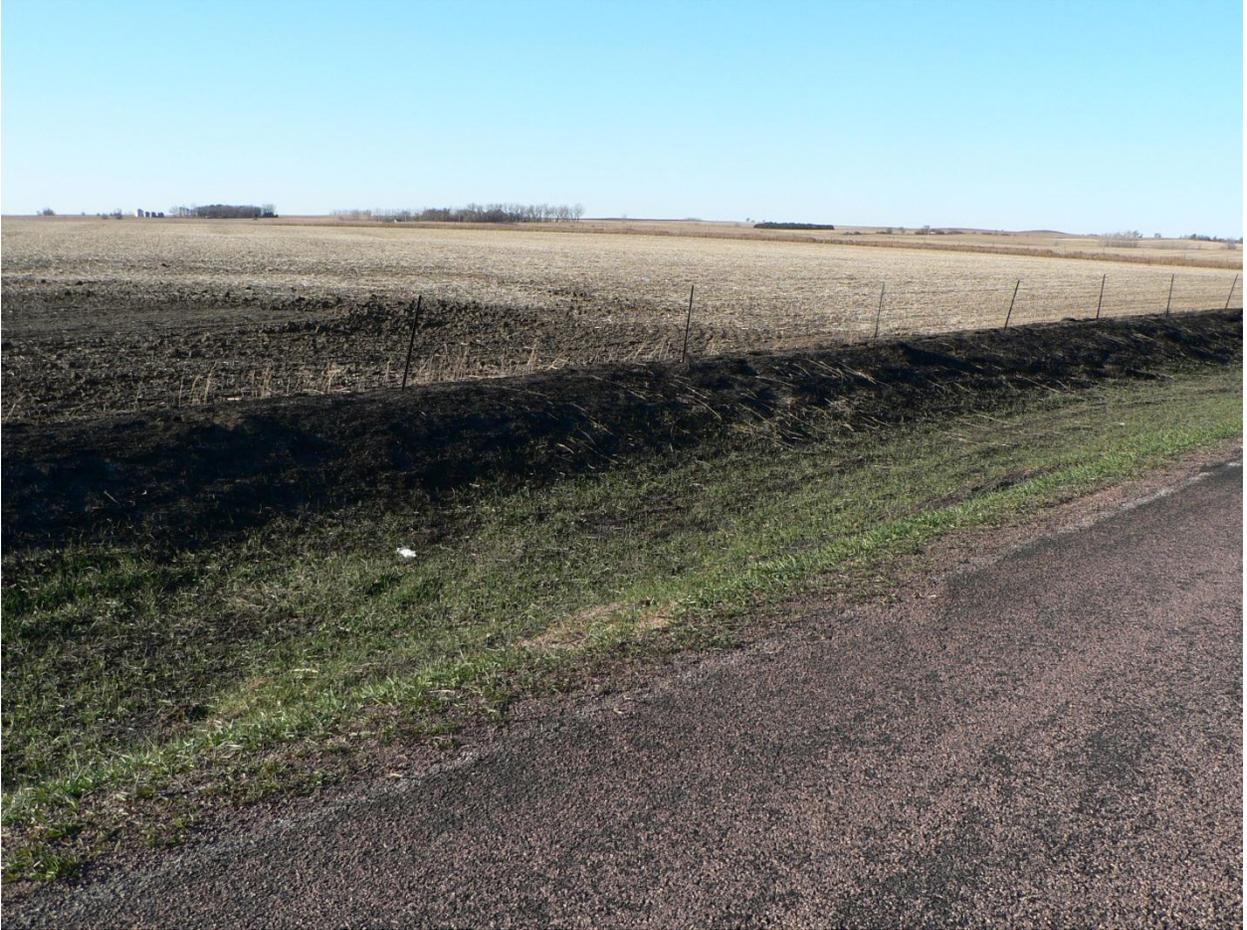
The topography across the fire consisted of gently rolling hills with some wet draws. The road ditch where the entrapment occurred was a steep drop off, approximately 5 feet deep, along a paved road.

Entrapment site looking south

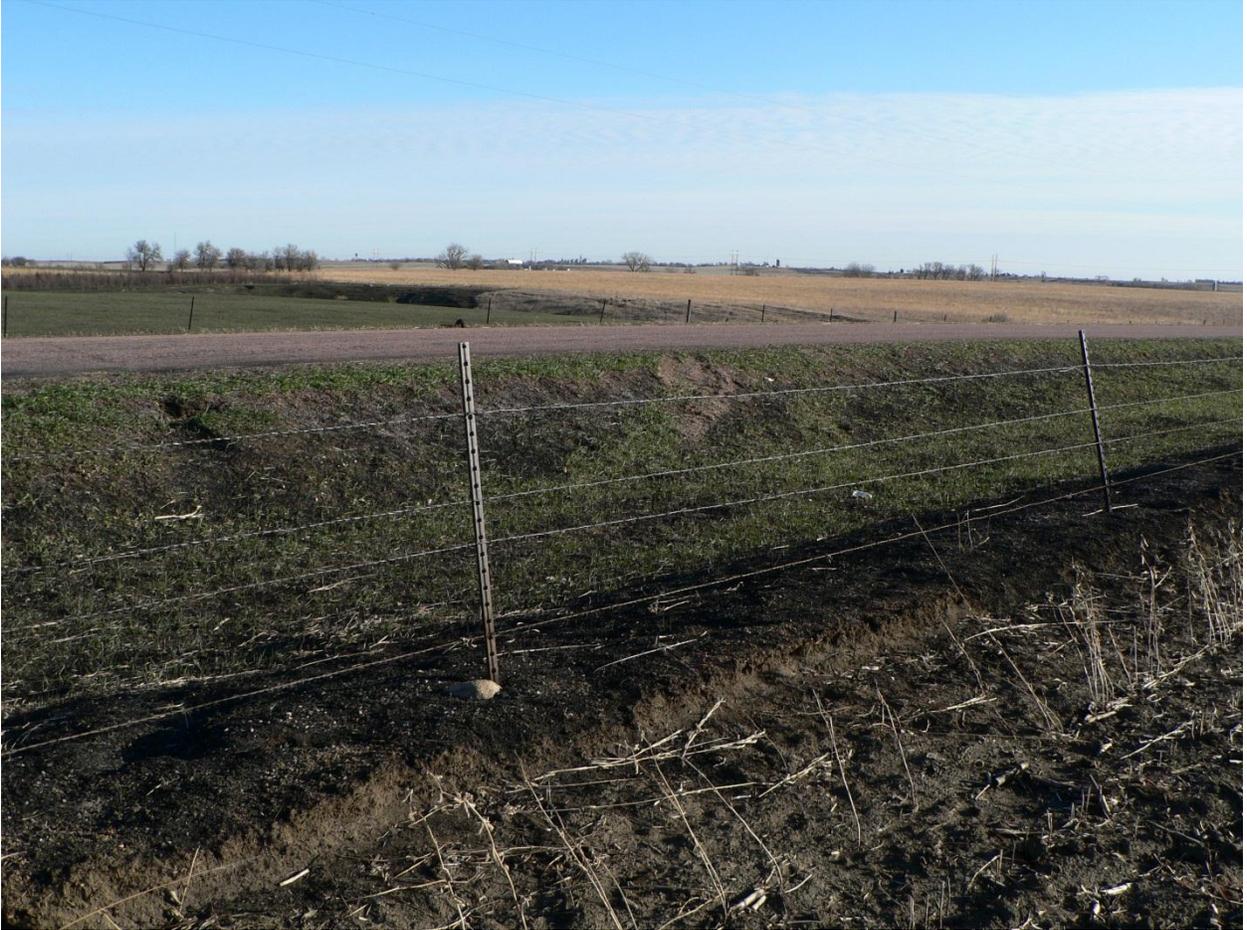
Entrapment site looking north

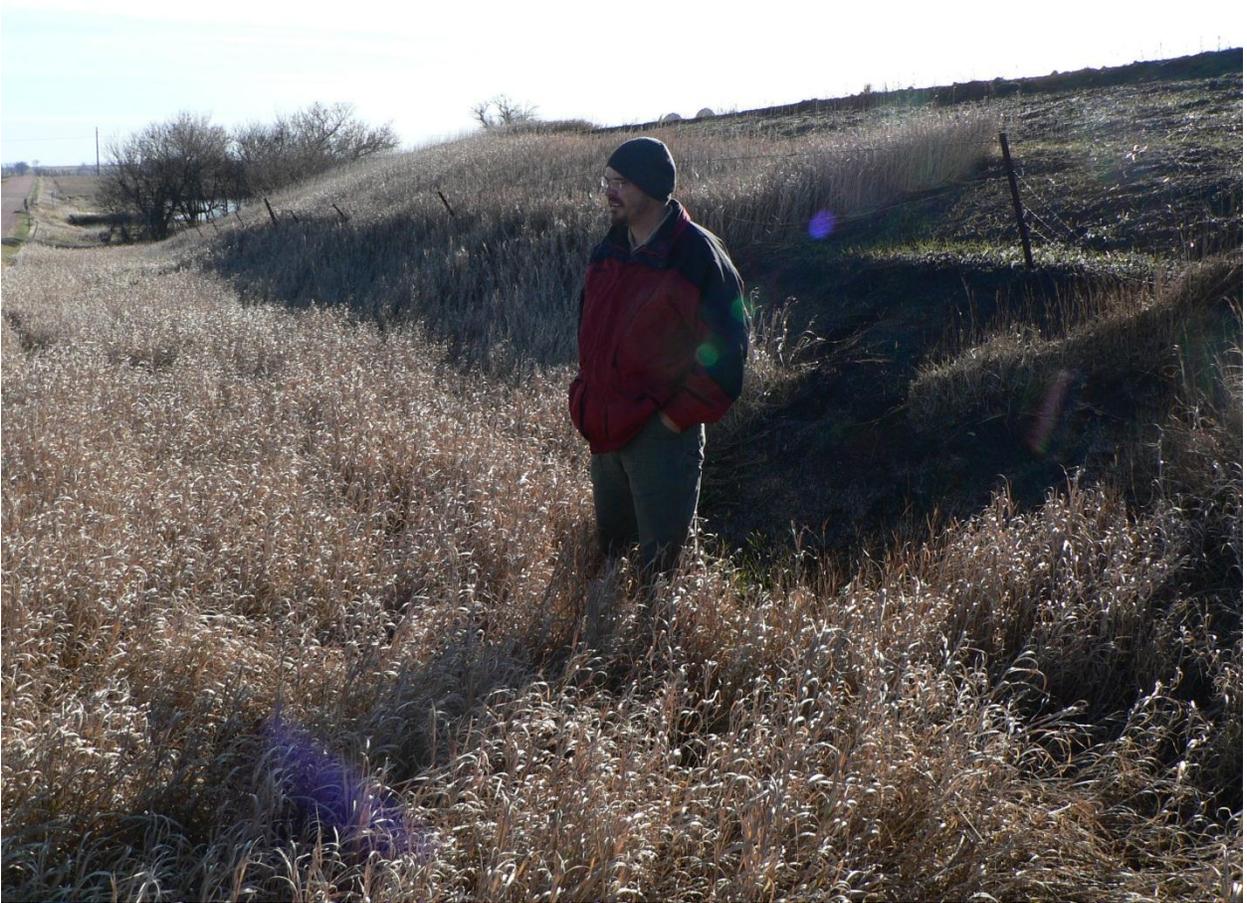
Fuels in the Tripp Lake Road Fire consisted of prairie grasses (brome) and a mix of harvested and un-harvested cropland (corn and soybeans). The grass had grown very tall (30") due to heavy spring moisture.

Fuel loading in ditch near entrapment site

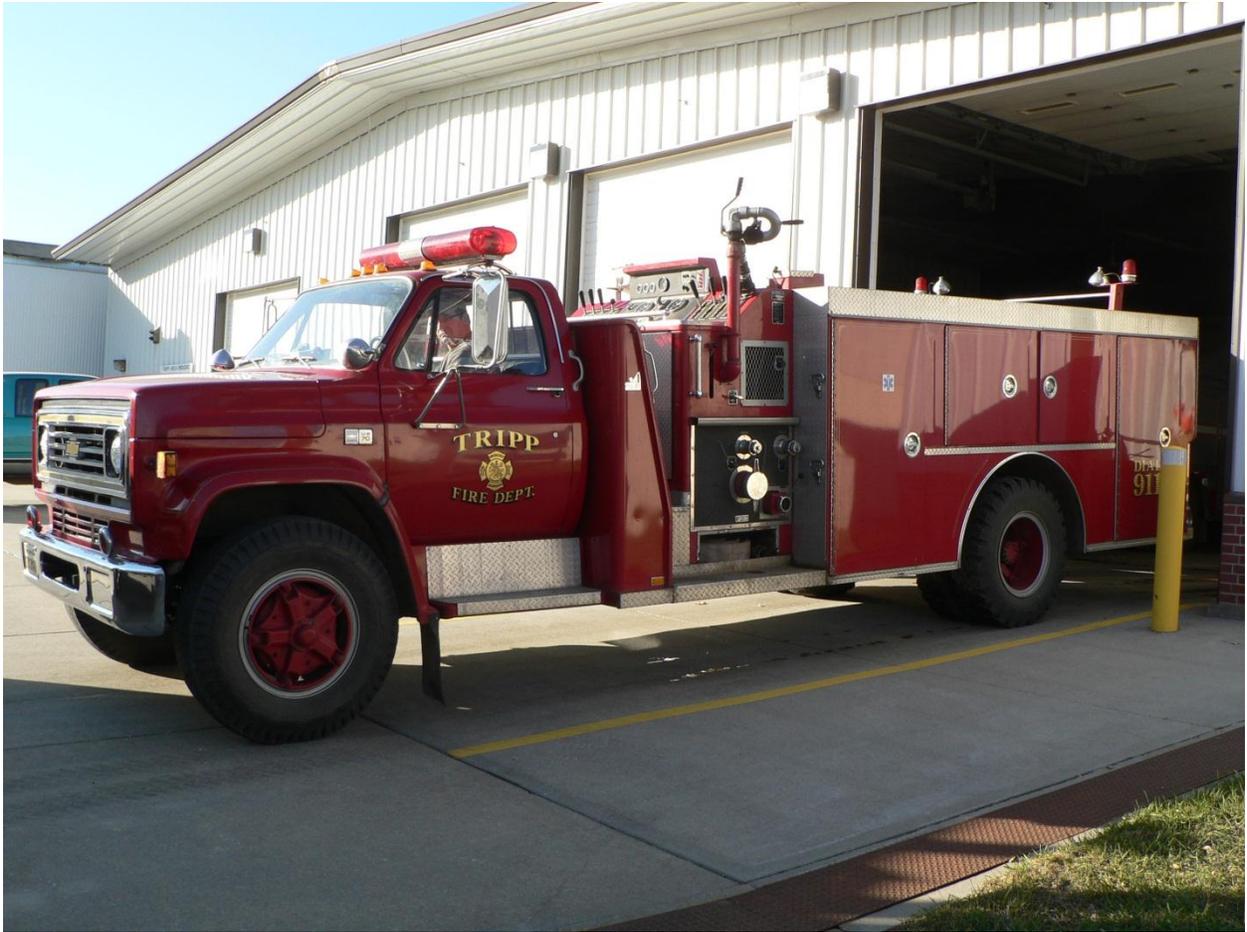
Tripp Volunteer Fire Department Engine driven during entrapment.
