Pest Update (January 17-24, 2018) Vol. 16, no. 2 John Ball, Forest Health Specialist SD Department of Agriculture, Extension Forester SD Cooperative Extension

Plant Development

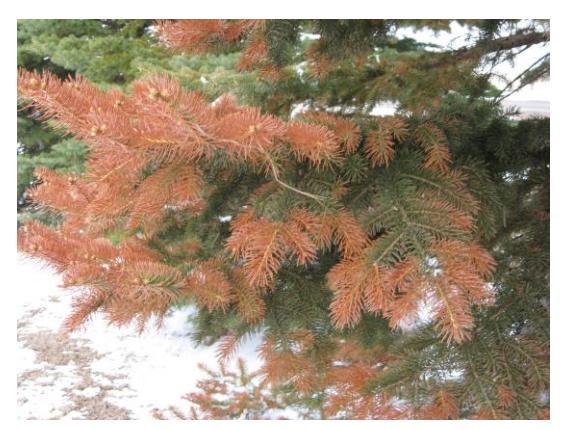
The eagerly anticipated January thaw has arrived throughout much of the state this past week. While the warmer weather has been a welcomed relief from the cold, it is alarming some tree owners as they are noticing their evergreens turning brown.

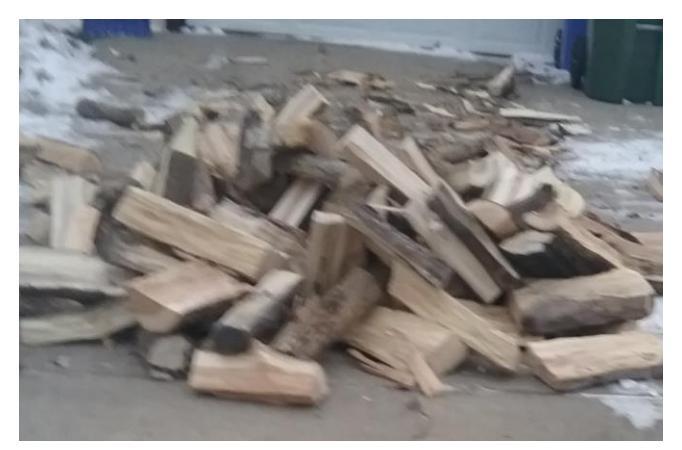
There seems to be a lot of homeowners still having firewood delivered to their home this winter. I took this picture of a pile of ash firewood that was just delivered to the home and the owner was in the process of stacking it. I asked where the wood came from – in a friendly way – and he thought the dealer was cutting trees out of old windbreaks near Parker. At least

the wood probably was not coming from Minnesota, Nebraska, or Iowa, all states with known infestations of emerald ash borer. If an infested tree is cut down in the fall, bucked and split into fuelwood then sold that winter, any wood still remaining in May can have adult beetles emerge from it. Emerald ash borer can only develop in a living tree, they will not attack a dead one so the concern is wood that was cut this fall and sold. Wood that has been split, the bark removed, and dried more than a year is not a concern as any emerald ash borers would have emerge from the wood the previous summer.

So a quick reminder if you are having firewood delivered to your home and it contains ash. Ask where the trees were cut and were they cut this past fall or before last spring. Ideally the trees are from a local in-state source and were harvested and split last spring before beetle emergence.

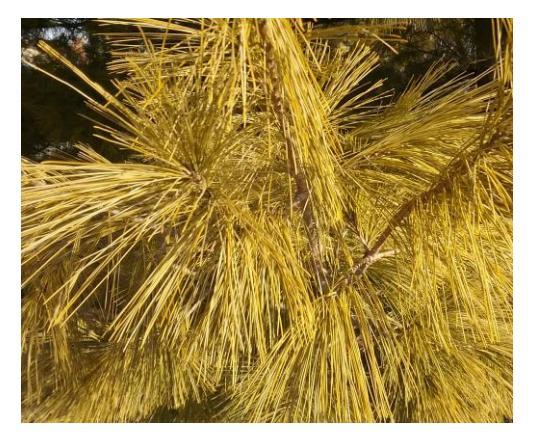
I have this picture of an eastern white pine that turned from an attractive bluishgreen to an ugly yellow-green. The question; was this winter burn? The tree apparently does this every year and it seems to be the worse in a grouping of eastern white pines (*Pinus strobus*), with some maintaining their attractive bluish-green needles while others turn yellow though not as bad as this one. The problem may not be winter burn at all, some eastern white pines also go through a color change in the fall,

such like Scotch pine, only to have the normal color resume as the weather warms in the spring.

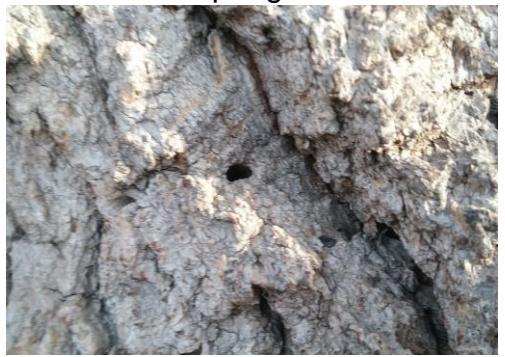
I found D-shaped holes in my ash tree, is this emerald ash borer? Fortunately, not. True these are D-shaped holes that were created as the borer emerged from the tree but the tree is not an ash, but an ash-leaf maple generally known as boxelder (*Acer negundo*). While it is hard to tell the scale of the D-shaped hole, it most likely was created by the maple borer (*Agrilus masculinus*).

This is a close relative to the emerald ash borer, but it is native to South Dakota and attacks declining trees rather than healthy one.

This brings up two requests to anyone that submits pictures of D-shaped holes in a tree – first, place something next to the hole, even a finger, so I have a sense of scale and two, take a close up picture of the tree (which these folks did) as well so I can see whether or not it's an ash.

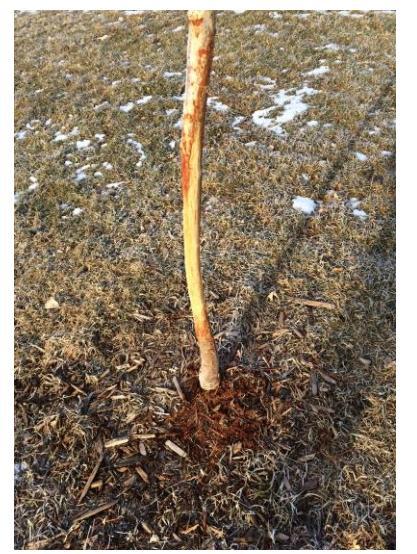
I received this picture of a deer rub from Josh, one of the South Dakota Department of Agriculture foresters in the Black Hills. As discussed in the November 28, 2017 Update, deer rub trees to 1) remove the velvet from the antlers and 2) to mark the tree as a signal this is their territory. Most of the damage we see is not from deer removing velvet that occurs over a relatively short time period in the fall - but from a few dominant bucks marking out their space. They begin rubbing sooner and continuing rubbing longer into the season. When they chose a tree, they rub more of it and will continue to come back to continue rubbing it during the season. These are the problem deer and it appears that they have killed this tree.

Usually if the bark has been removed more than one-third the way around the stem, the tree *may* not survive. If it's more than two-thirds around the stem, the tree *will* not survive. It may send up a few sprouts along the base, but it will probably never recover to be an attractive tree. Note it's the circumference that the deer rub, not the length that determines survival. Rubbing the bark off around the trunk severs the connection between the leaves and the roots. This can reduce the amount of food reaching the tree's roots and result in their starvation.

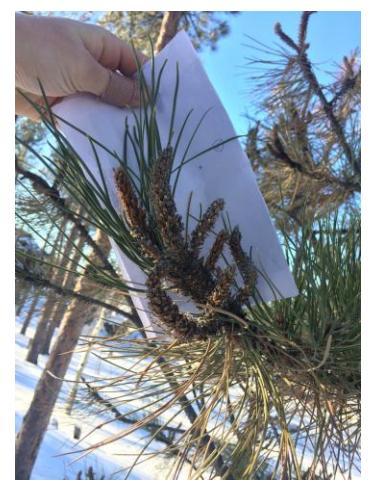
Fall River County ponderosa pine?

What is wrong with this

Anthony, another one of our Department of Agriculture foresters in the Black Hills, send this picture and some samples. These pine shoots are presenting the classic symptoms of injury from a growth-regulator herbicide – abnormal thickening of the tips. The most common herbicide I have run across that causes these symptoms is picloram. Tordon is a common herbicide that contains picloram as its active ingredient and it is used to manage broadleaf weeds. The label also mentions it can be used to kill woody plants, such as pines, but sometimes people do not read that far. The label also mentions not to use it within the rooting zone of desirable trees. This distance is much farther out

than most applicators realize. The rooting distance can be at least as far from the tree as it is tall. So a 40-foot pine may have roots extending out from the trunk at least 40 feet.

There is no rule say a plant can only have one problem at a time so it may be a combination of both. I know it has a high scale population. The only way to know for certain if picloram is responsible any injury is tissue testing and the analysis will be covered in an upcoming *Update*.

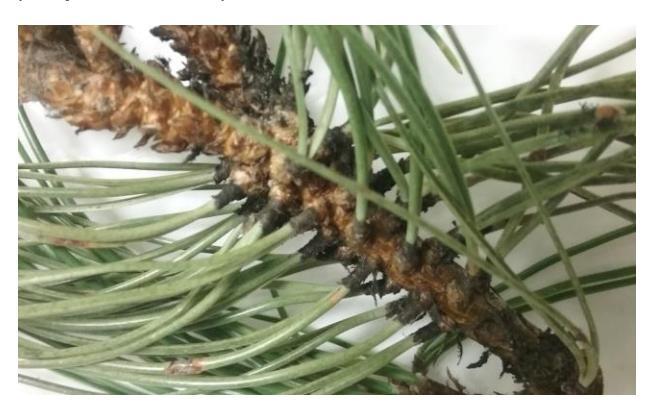
However, while this swelling is a classic symptom for herbicide injury, this is not the only possible causal agent. The samples were covered with striped pine scale (*Toumeyella pini*), a close (and western) relative of the pine tortoise scale (*T. parvicornis*). These are soft scales that feed by sucking the sap from the

shoots. High populations on a shoot can stunt the development of the new growth and also cause some distortion. The other symptom of high scale populations is the presence of honey dew that is excreted by the scales as they feed and black sooty mold that colonizes this sweet substrate. The shoots submitted for testing were also covered with the mold.
